Technical Report 05-08

Utilizing Lignosulfonates for Gravel Shoulder Stabilization

*Construction, First, and Second Interim Report
September, 2007*

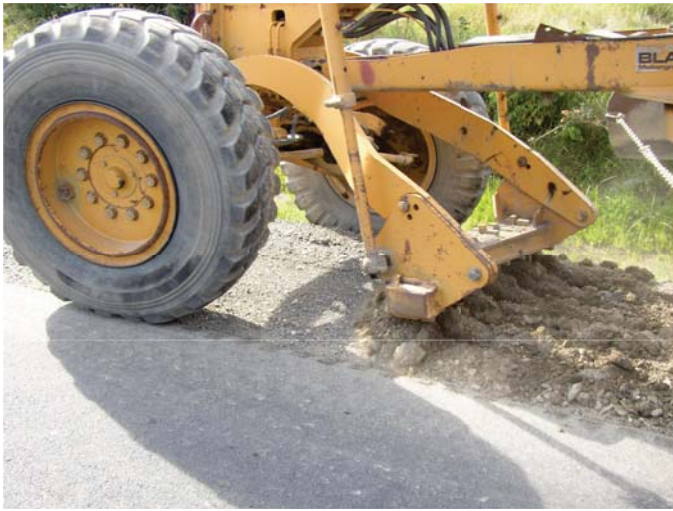
Photo 1 Scarifying Compacted Shoulder Gravel

Maine Potato Growers Incorporated was contracted to dispense TDS. The process began with scarifying the north bound gravel shoulder to a depth of 6 inches with a grader, as shown in Photo 1. TDS is then applied over the scarified shoulder at a manufacturers suggested rate of 0.35 gal/yd², see Photo 2. Additional gravel is placed over the treated gravel and the material is brought to grade as displayed in Photo 3. A second coat of TDS is applied at a rate of 0.35 gal/yd², as displayed in Photo 4, and the treated gravel shoulder is then compacted with a Caterpillar CP-323 vibratory compactor, Photo 5. A third coat of TDS is applied at a manufacturers suggested rate of 0.1 gal/yd² to seal the compacted shoulder. Photo 6 displays the compacted shoulder after the final coat.

While scarifying the north bound shoulder it was apparent that there were a number of large pieces of compacted gravel left behind. This can be seen in Photos 1 and 2. To get good stability it's necessary to coat the gravel completely, in particular fine grain material that passes the 200 sieve. In order to get proper TDS penetration, the grader made a second pass with the blade to break up the large gravel pieces. This procedure worked quite well and was used to scarify the remaining shoulders. It took three days to complete stabilization of the shoulders.

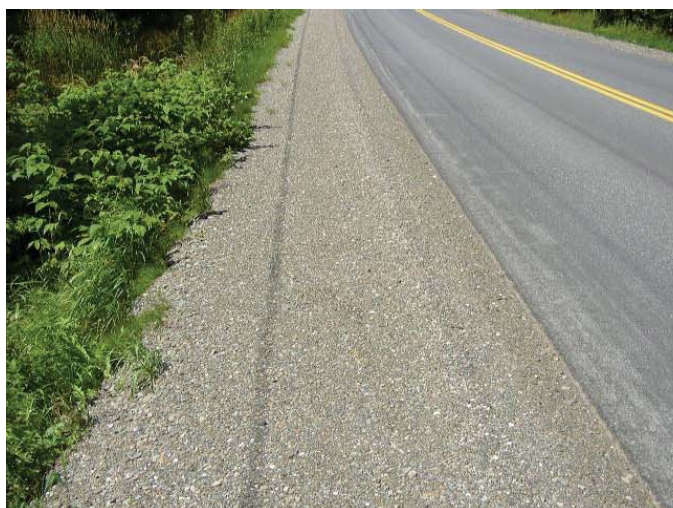
Photo 7 PIN 11538.00 Experimental Section

The experimental section looks very good with no erosion or vegetation on the shoulders as displayed in Photo 7. The gravel shoulder is even with the pavement surface and the gravel surface is very firm.

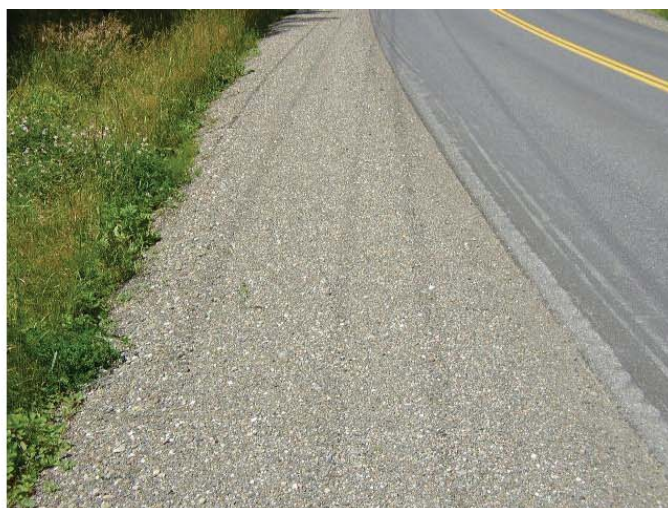
Photo 8 PIN 11538.00 Control Section

The Control Section has no erosion and no vegetation. The gravel is even with the roadway as displayed in Photo 8.

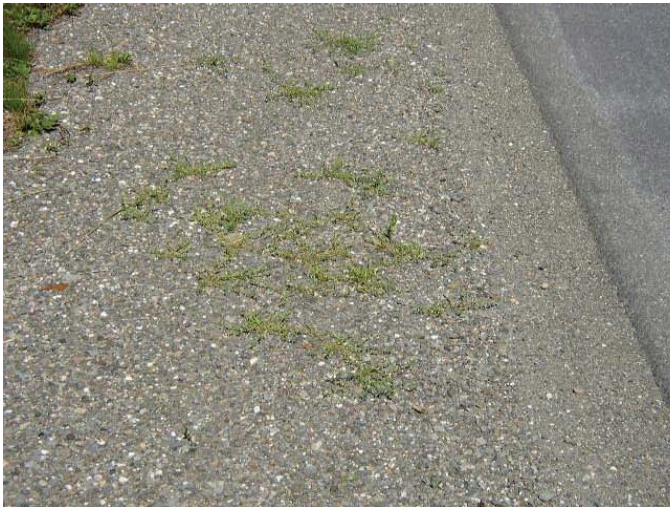
Photo 9 Experimental Section Vegetation

The Experimental Section is in very good condition. A small amount of vegetation is beginning to grow on the shoulder as displayed in Photo 9. There is an elevation change of 0.5 inches between the shoulder and pavement. It appears that a portion of the untreated shoulder gravel that was placed after the project was surfaced with HMA has eroded away as displayed in Photo 10. The gravel shoulder feels solid under foot.

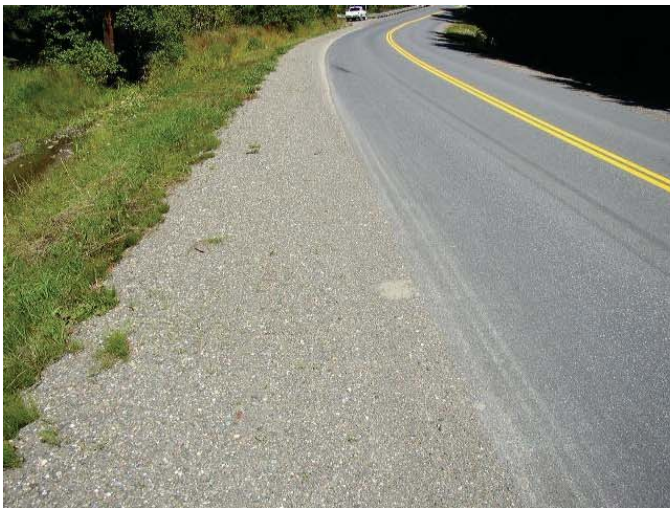
Photo 11 Control Section

The Control Section is in very good condition with less vegetation than the Experimental Section as displayed in Photo 11. Shoulder gravel elevation is 1.0 inch below the pavement. This Section is located on an outside curve and it appears that the elevation change is caused by traffic riding on the shoulder as displayed in Photo 12.

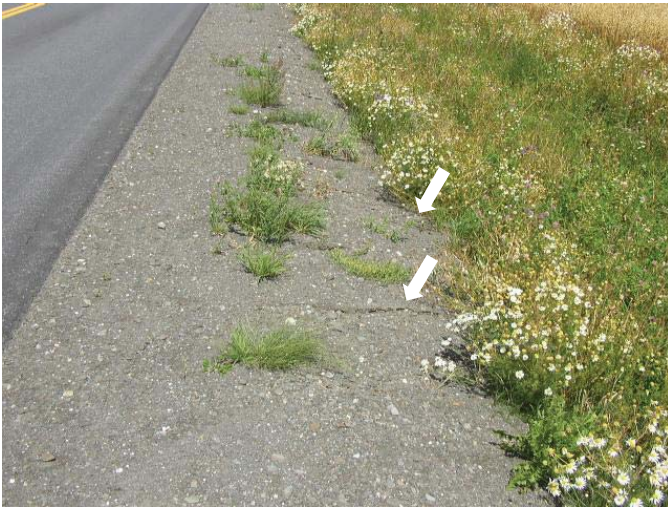
Photo 13 Experimental Section Erosion Lines

There are many areas within the Experimental Section that have erosion lines. Erosion lines begin 3.5 feet from the edge of pavement and run from that point to the ditch line and are between 2 and 3 inches deep as displayed in Photo 13. Photo 14 displays vegetation growing on the shoulders and there is a 0.5 inch elevation change between shoulder and pavement. It appears that the gravel shoulder is stable from the pavement edge to roughly 3 feet from the edge. The project resident stated that they had moderate rains shortly after the shoulders were treated and the TDS may not have had enough time to cure. Another issue is the amount of fines in the shoulder gravel. This project has 3.5 percent passing the # 200 sieve whereas the Madawaska project has 8.0 percent. The TDS representative stated that he typically likes to work with soils that have 10 percent or greater passing the # 200 sieve.

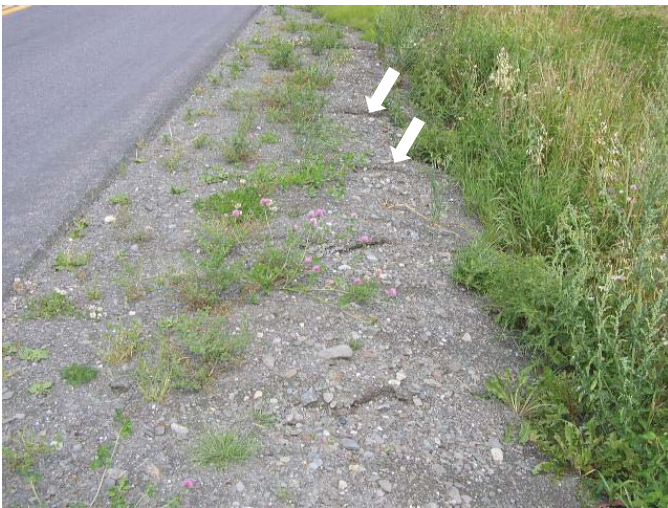
Photo 15 Control Section Erosion Lines

The Control Section has more erosion and vegetation than the Experimental Section. The erosion pattern is similar but the erosion lines begin roughly 2.5 feet away from the pavement edge as displayed in Photo 15. Vegetation has covered considerably more shoulder area as displayed in Photo 16.

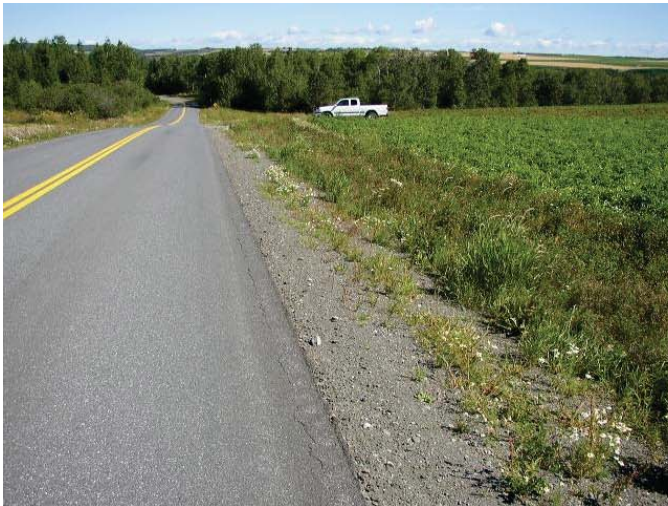
Photo 17 Experimental Section Vegetation

The Experimental Section has less visible erosion and more vegetation than last year is shown in Photo 17. The MaineDOT Maintenance Division re-graded the shoulders in early 2007. The gravel is 1.0 to 1.5 inches below pavement elevation as shown in Photo 18.

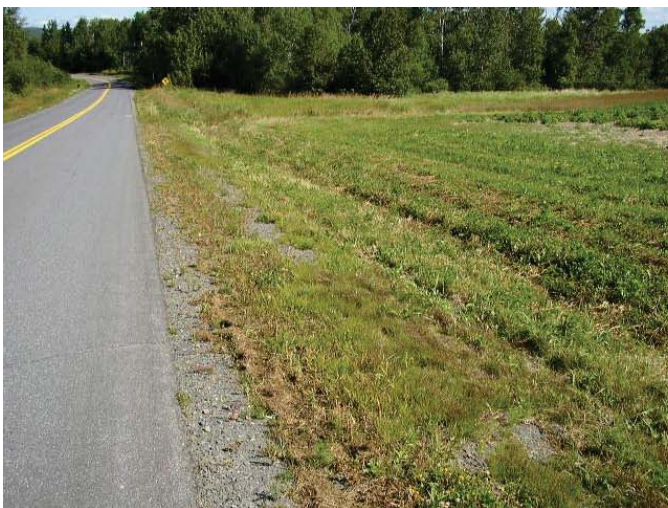
Photo 19 Control Section Vegetation

The Control Section is almost completely covered with vegetation as displayed in Photo 19. The amount of erosion is similar to the Experimental Section and the elevation change is between 1.5 and 2.0 inches deep as displayed in Photo 20.
